WMV bv.
Lunac 2+ duplex
NBD 10300 (2010) Qualification Test

Client: WMV bv.
Contact: Mr. G. van der Sluis

Date: September 26, 2011
Author: Guus Coolegem
Reference: CCubeR11-09211
Status: Final

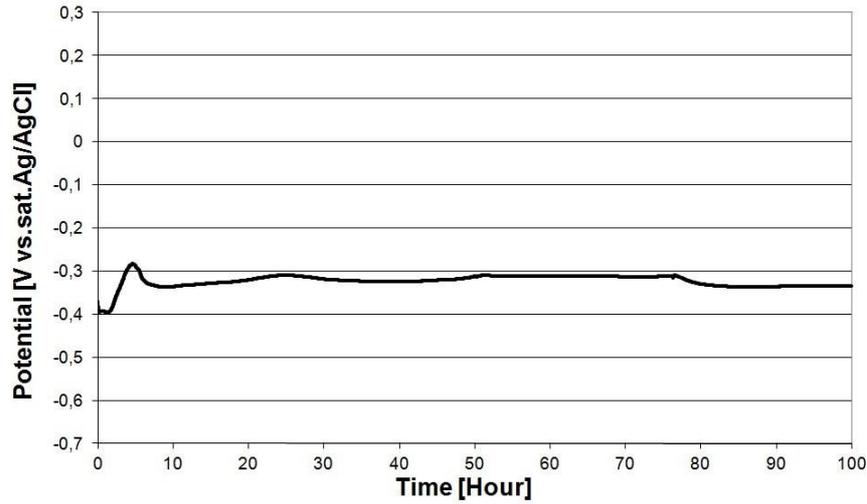
Figure 1: Potential measurement of the Lunac 2+ coating, for 100 hours.

The potential after 100 hours immersion is -0.33V. After this test a polarization curve has been measured, see Figure 2.

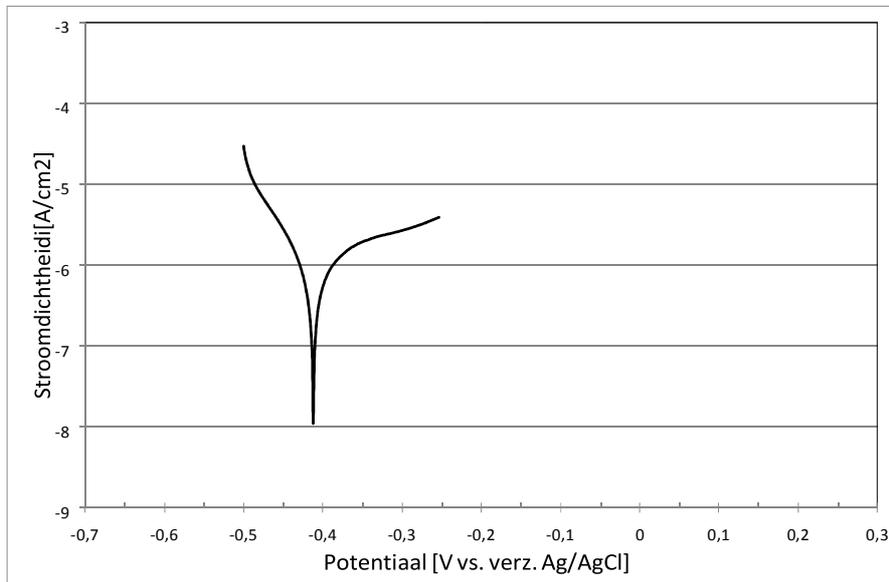
Figure 2: Polarization curve of the Lunac 2+ coating, at 0.5mV/s.

Interestingly, the potential of the polarization curve is equal to the potential at the start of the potential measurements. This indicates that the oxide layer which has built up in 100 hours during the negative polarization in the first part of the polarization curve (left of the V-shape) breaks down locally.

With the polarization resistance, the Tafel gradient and modelling of the curve (ISO 17475), the corrosion current density was derived,

at a level of $I_{corr} = 0.5 \mu A/cm^2$, corresponding to a corrosion rate of 1-4 μm per year. The repassivating potential I_{repass} could not be determined as a result of the uniform corrosion mechanism.

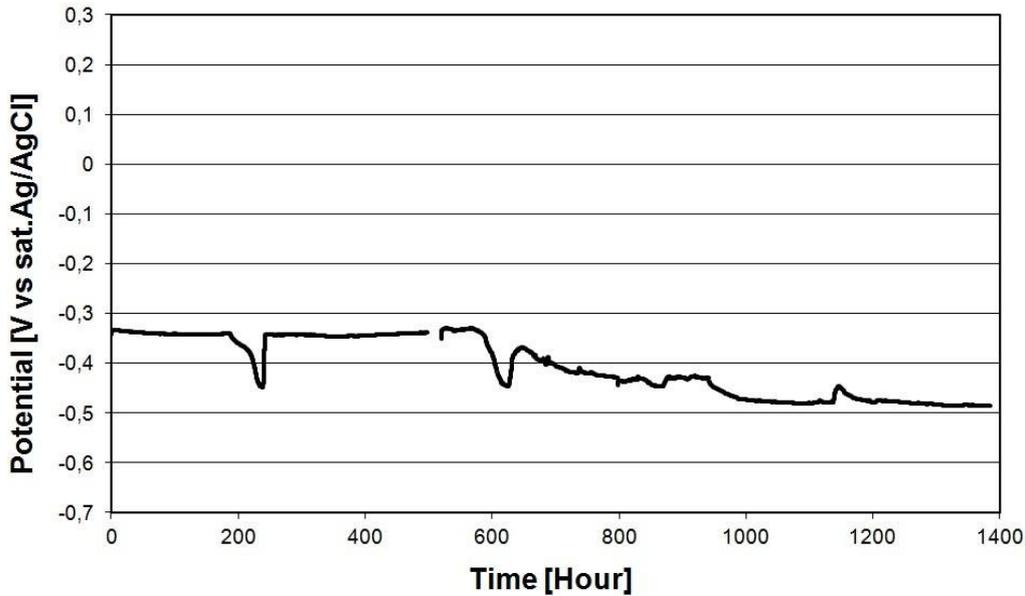
Figure 3: Galvanostatic test, during 1400 uur at $5 \mu A/cm$.

From the shape of the graph of the galvanostatic test it can be determined that the coating activates during the test. After the test, the measured potential is: -0.34 V vs. sat. Ag/AgCl. Since this is very stable, the chart has not been included in this report. After the potential measurement of 100 hours a polarization curve has been measured, see Figure 4.

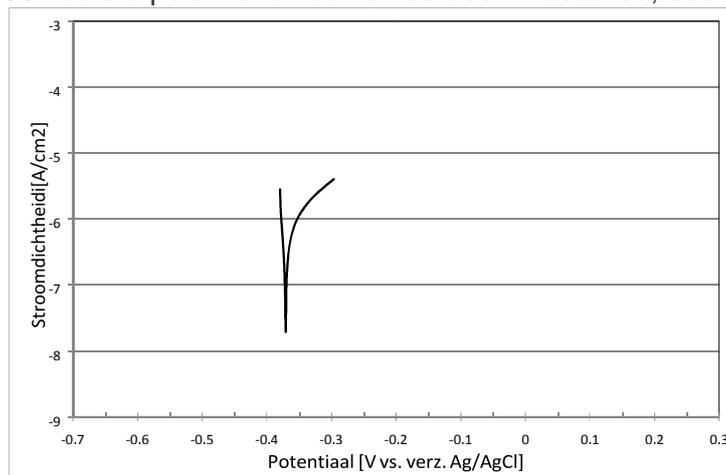
Figure 4: Polarizationcurve after the galvanostatic test.

The potential in the polarization curve is -0.36 V, slightly lower than the potential measurement. The corrosion current density in the curve is $0.6 \mu A/cm^2$, the corrosion rate is almost equal to the corrosion rate before the

test, 1.5 to 4.5 μm / year. The corrosion mechanism is uniform corrosion, which can be seen at the positive right branch. Photographs of the surface are given in Figure 5.

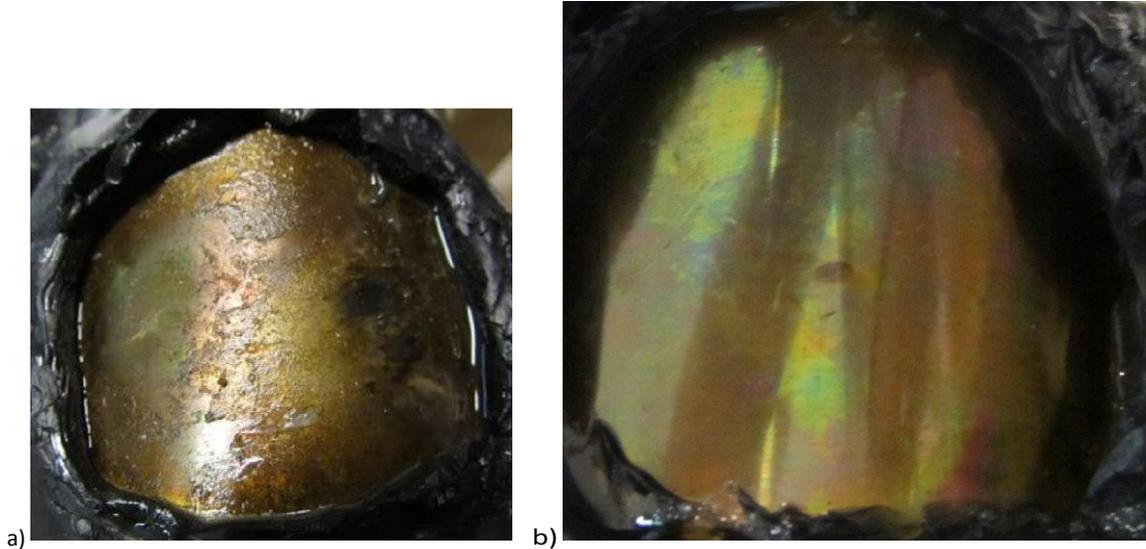
Figure 5: The surface after testing, before (a) and after 9b) removing the debris product with a cloth.

The surface looks stable, in the middle of the surface a small area is present with a different color. There is no visually observable damage to the surface, even in the middle area.

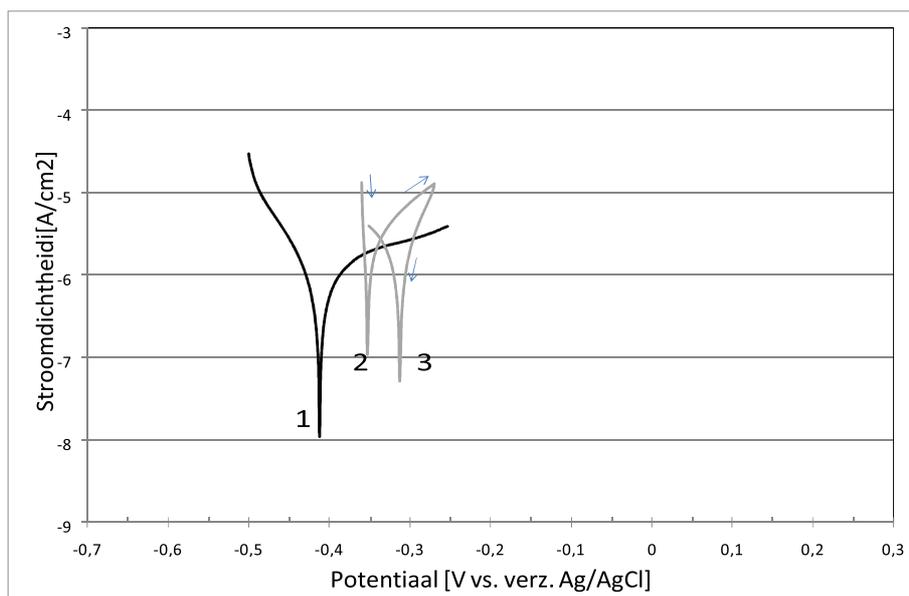
During positive polarization, the corrosion rate first increases and then decreases again because a new thicker oxide layer builds up. This can be visualized by recording consecutive polarization curves, see Figure 6.

Figure 6: Consecutive polarization curves,, where the corrosion rate is proportional to the height of the V-shape in the graph. The second curve, taken immediately after the first, is higher, and at the retreating measurement the V-shape is at a lower level (= proportional to corrosion rate).
