WMV bv.
Lunac 2+ duplo
NBD 10300 (2010) Qualification Test

Client: WMV bv.
Contact: Mr. G. van der Sluis
Date: September 26, 2011
Author: Guus Coolegem
Reference: CCubeR11-09211
Status: Final

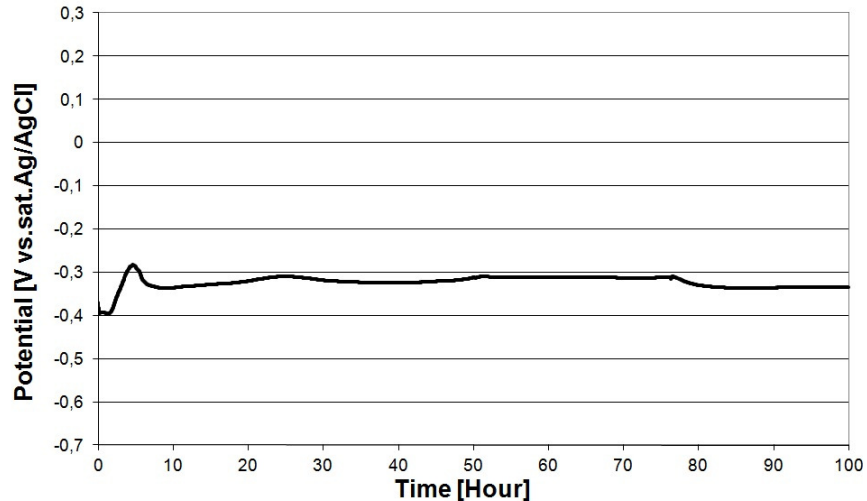
For the test sample, the potential has been measured in 3.4% NaCl solution for 100 hours from the start of the test, see Figure 1.

Figure 1: Potential measurement of the Lunac 2+ coating, for 100 hours.

The potential after 100 hours immersion is -0.33V. After this test a polarization curve has been measured, see Figure 2.

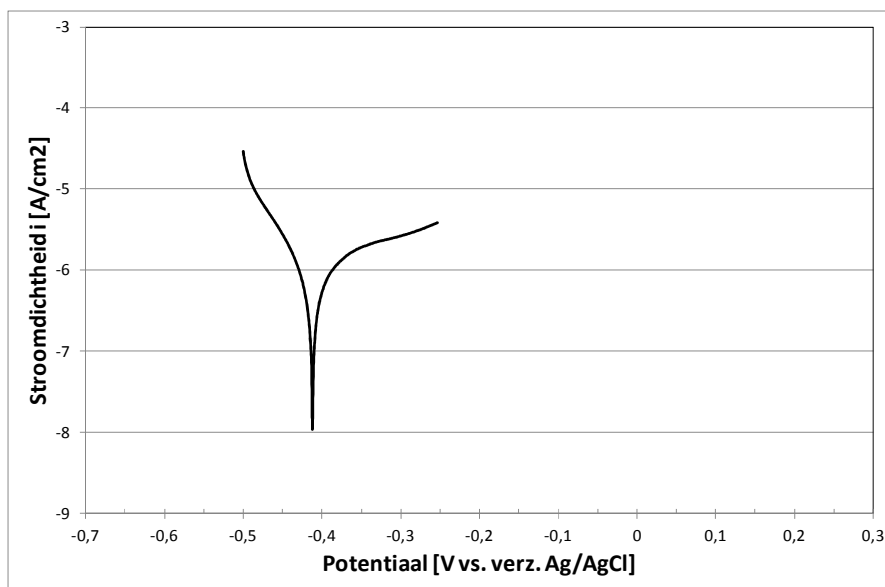
Figure 2: Polarization curve of the Lunac 2+ coating, at 0.5mV/s.

Interestingly, the potential of the polarization curve is equal to the potential at the start of the potential measurements. This indicates that the oxide layer which has built up in 100 hours during the negative polarization in the first part of the polarization curve (left of the V-shape) breaks down locally.

With the polarization resistance, the Tafel gradient and modelling of the curve (ISO 17475), the corrosion current density was derived, at a level of $i_{\text{corr}} = 0.5 \mu\text{A}/\text{cm}^2$, corresponding to a corrosion rate of 1-4 μm per year. The repassivating potential i_{repass} could not be determined as a result of the uniform corrosion mechanism.

Based on the polarization curve, the current density for the test is determined for the galvanostatic exposure $\text{galvstat} = 5 \mu\text{A}/\text{cm}^2$. For more than 1000 hours, 1400 hours this current is observed, see Figure 3.

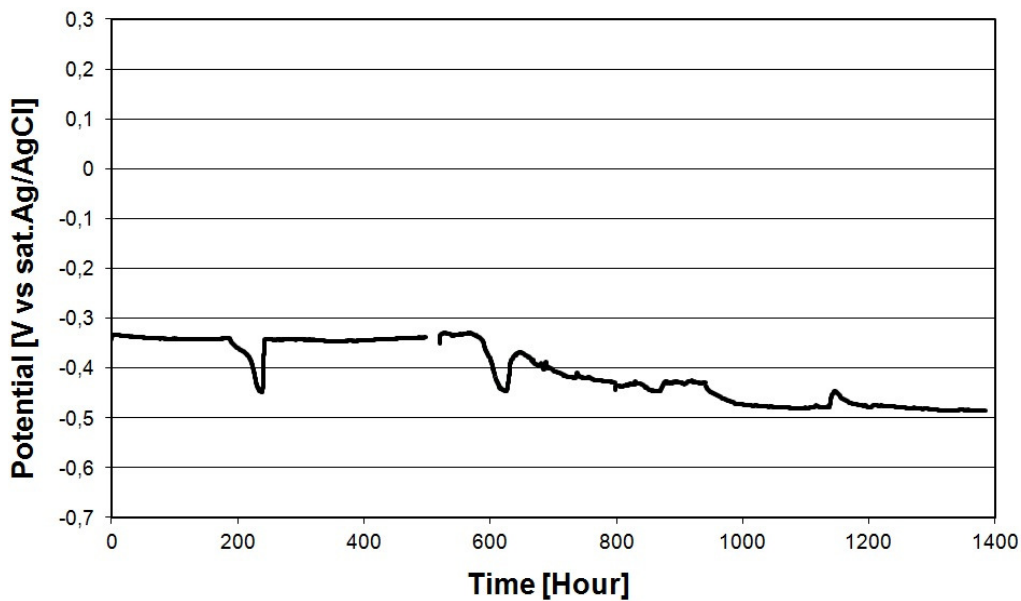
Figure 3: Galvanostatic test, during 1400 uur at $5 \mu\text{A}/\text{cm}^2$.

From the shape of the graph of the galvanostatic test it can be determined that the coating activates during the test. After the test, the measured potential is: -0.34 V vs. sat. Ag/AgCl. Since this is very stable, the chart has not been included in this report. After the potential measurement of 100 hours a polarization curve has been measured, see Figure 4.

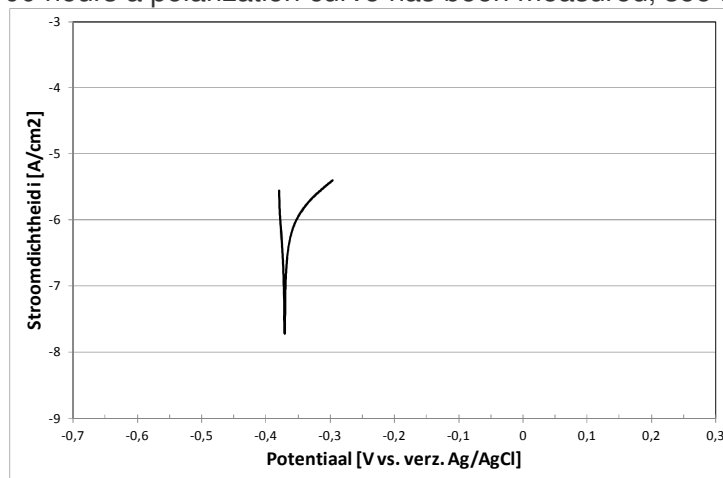
Figure 4: Polarizationcurve after the galvanostatic test.

The potential in the polarization curve is -0.36 V, slightly lower than the potential measurement. The corrosion current density in the curve is $0.6 \mu\text{A}/\text{cm}^2$, the corrosion rate is almost equal to the corrosion rate before the test, 1.5 to $4.5 \mu\text{m} / \text{year}$. The corrosion mechanism is uniform corrosion, which can be seen at the positive right branch. Photographs of the surface are given in Figure 5.

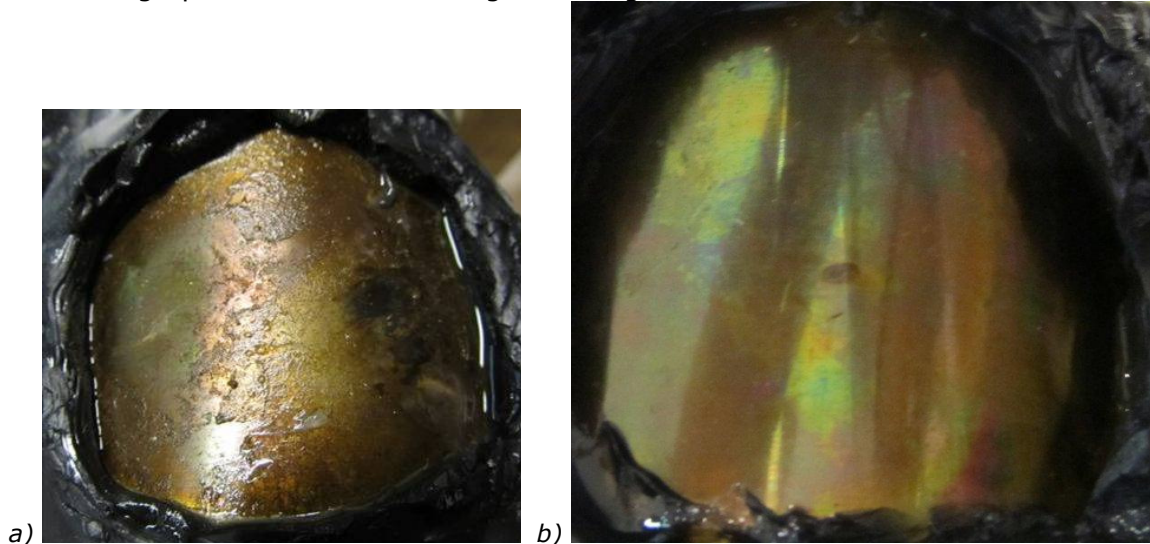
Figure 5: The surface after testing, before (a) and after 9b) removing the debris product with a cloth.

The surface looks stable, in the middle of the surface a small area is present with a different color. There is no visually observable damage to the surface, even in the middle area.

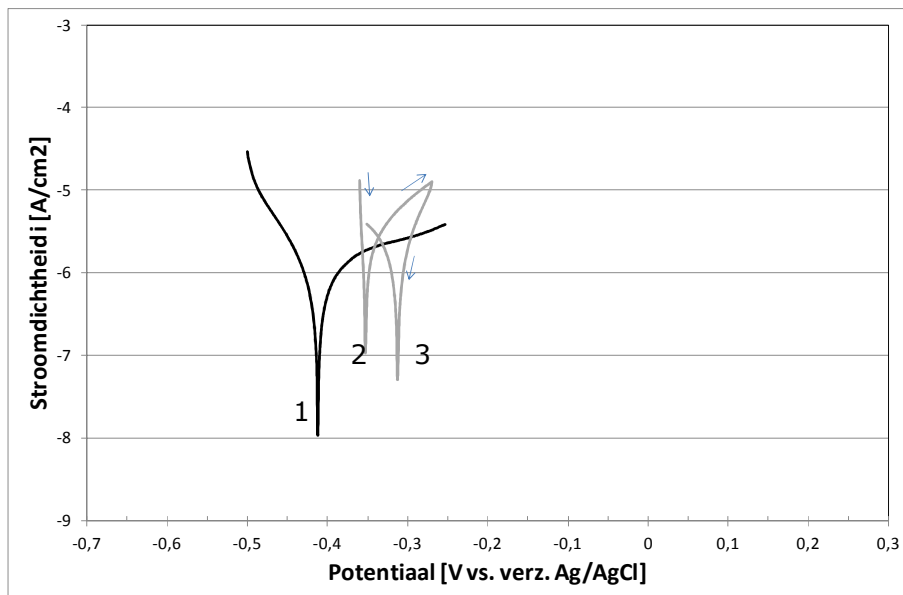
During positive polarization, the corrosion rate first increases and then decreases again because a new thicker oxide layer builds up. This can be visualized by recording consecutive polarization curves, see Figure 6.

Figure 6: Consecutive polarization curves, where the corrosion rate is proportional to the height of the V-shape in the graph. The second curve, taken immediately after the first, is higher, and at the retreating measurement the V-shape is at a lower level (= proportional to corrosion rate).
